# Case Studies in Building Rehabilitation

# Characterization of Ancient Mixed Masonry Structures of Brickwork Infilled by Cobblestone Wall

**Keywords** Masonry structures · Architectural heritage · Laboratory experiments · In situ campaign

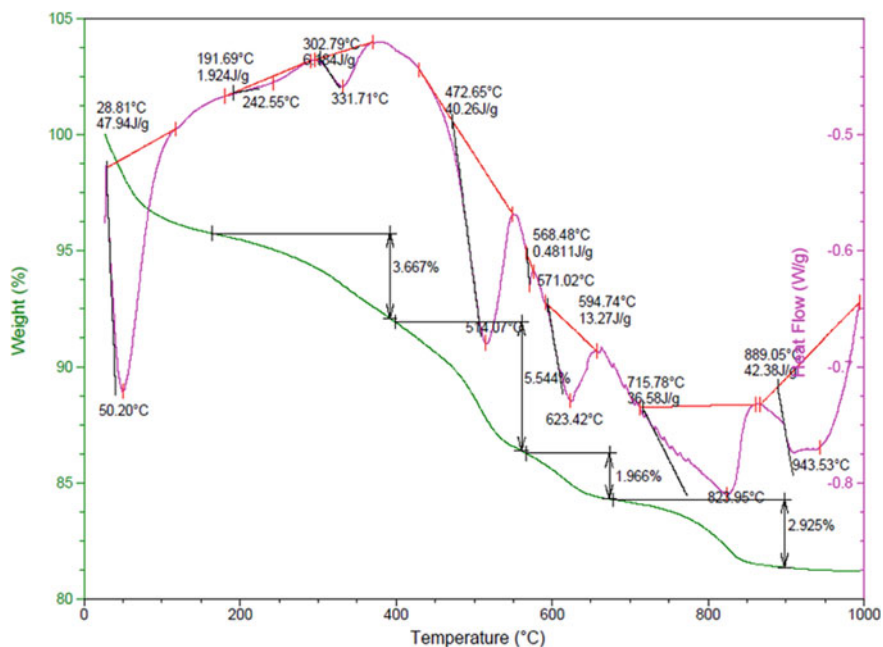
**Fig. 6** TGA/DTA analysis of the 15–18th century brick

This (TGA/DTA) technique was similarly used on samples extracted from the pieces of brick. Figures 6 and 7 show a loss of weight due to evaporation of water up to 100 °C, indicating greater humidity and thus porosity in the sample from the first period, 15–18th century, with respect to the second period, 19–20th century. The loss of weight at 800 °C indicates the presence of calcium carbonate caliches, the samples from the first period showing greater presence of caliches than in those of the second period. In the first period brick, a greater number of endothermic peaks was observed, which indicates the presence of a greater quantity of clays that have not been fired, given that in their manufacture they underwent lower temperatures.

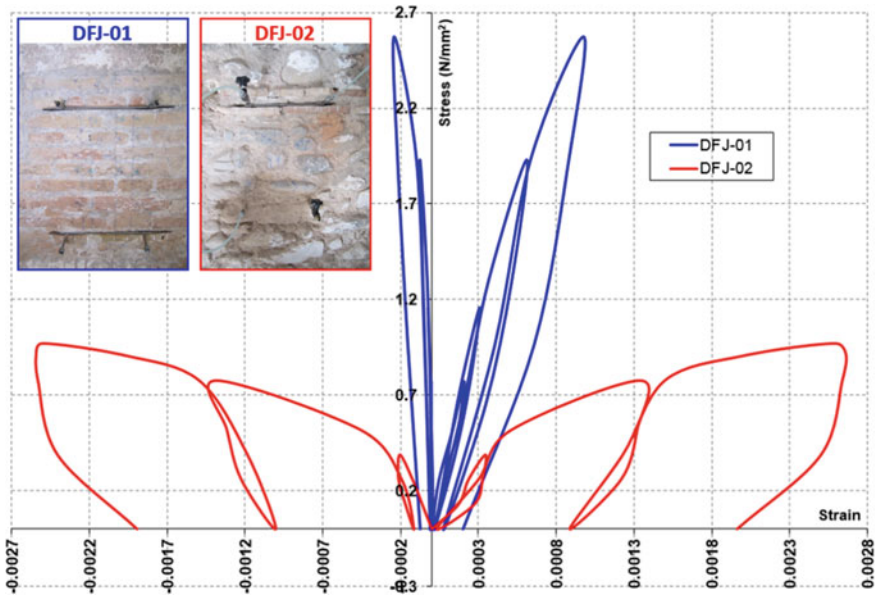
**Fig. 8** Comparison of the average  $\sigma$ - $\varepsilon$  laws obtained in test DFJ-01 (19–20th century wall) and in DFJ-02 (15th century wall supposedly remodelled in the 18th)

Test DFJ-01 had the aim of determining the modulus of deformation and Poisson's ratio of the inner leaf of the brick masonry forming one of the load-bearing walls of the extension built in the 19–20th century. While test DFJ-02 allowed to determine the equivalent parameters in the inner leaf of the 15th century load-bearing wall, supposedly remodeled in the 18th century, built of a mixed masonry of brickwork infilled with cobblestone and lime mortar. A comparison of the average  $\sigma$ - $\epsilon$  laws obtained in the tests is shown in Fig. 8.

From the curves shown in Fig. 8, it can be seen that in the case of DFJ-01 there is linear behavior until around 1.20 MPa, so that magnitude is related to the elastic limit of the masonry. From the study of the envelope curve of the non-linear behavior zone (Lombillo et al. 2013, 2014), a compressive strength of 3.88 MPa can be estimated associated to a deformation of 3‰ (Tassios 1988), a congruent value bearing in mind that the first fissure affecting one of the pieces forming the wall developed at a working pressure of the pump of 4 MPa. The secant modulus of elasticity determined was 3674 MPa and its Poisson's ratio was 0.06. In the case of DFJ-02, the elastic limit was of 0.40 MPa and, carrying out an analogous study to the previous one, the

compressive strength was estimated to be 1.02 MPa, the secant modulus of elasticity was of 1513 MPa and Poisson's ratio 0.47.
