**WEB-GIS APPROACH TO PREVENTIVE CONSERVATION OF HERITAGE  
BUILDINGS**

**Abstract**

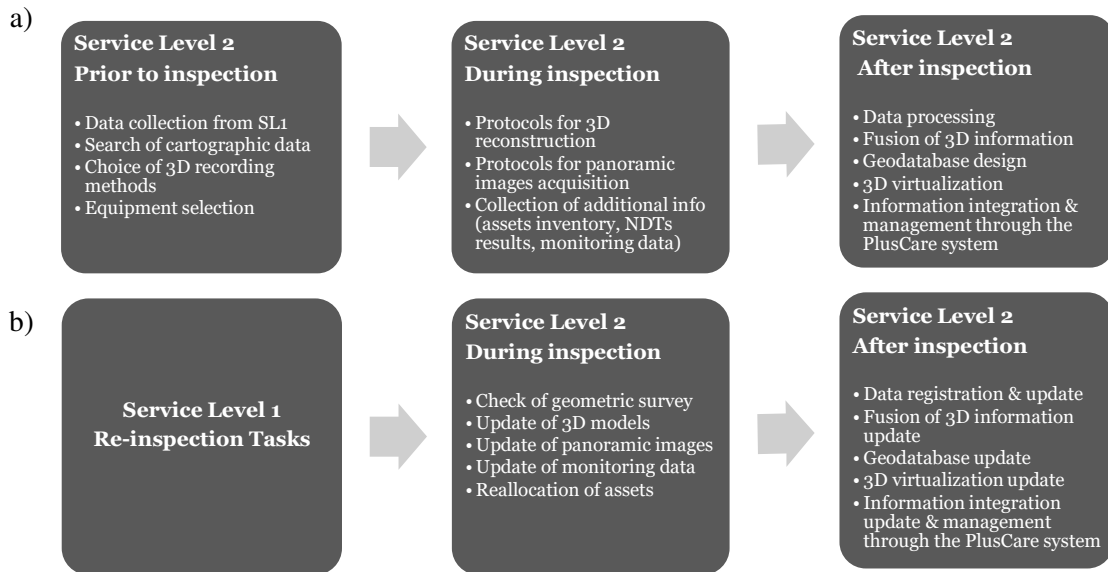
115 Figure 1: Workflows for the application of the PlusCare protocol according to the starting condition: a) absence of a  
116 previous SL2 inspection; and b) existence of a previous SL2.

108 As highlighted in the introduction, the main goal of this work is to show in detail the development  
109 phase of the PlusCare protocol, which corresponds to the second service level (SL2) of the  
110 HeritageCare method. This level is conceived to increase the knowledge of the inspected heritage  
111 buildings and related indoor assets, integrating and complementing the information collected in  
112 SL1. The protocol includes two similar workflows depending on the existence or not of a previous  
113 SL2 inspection (Figure 1).

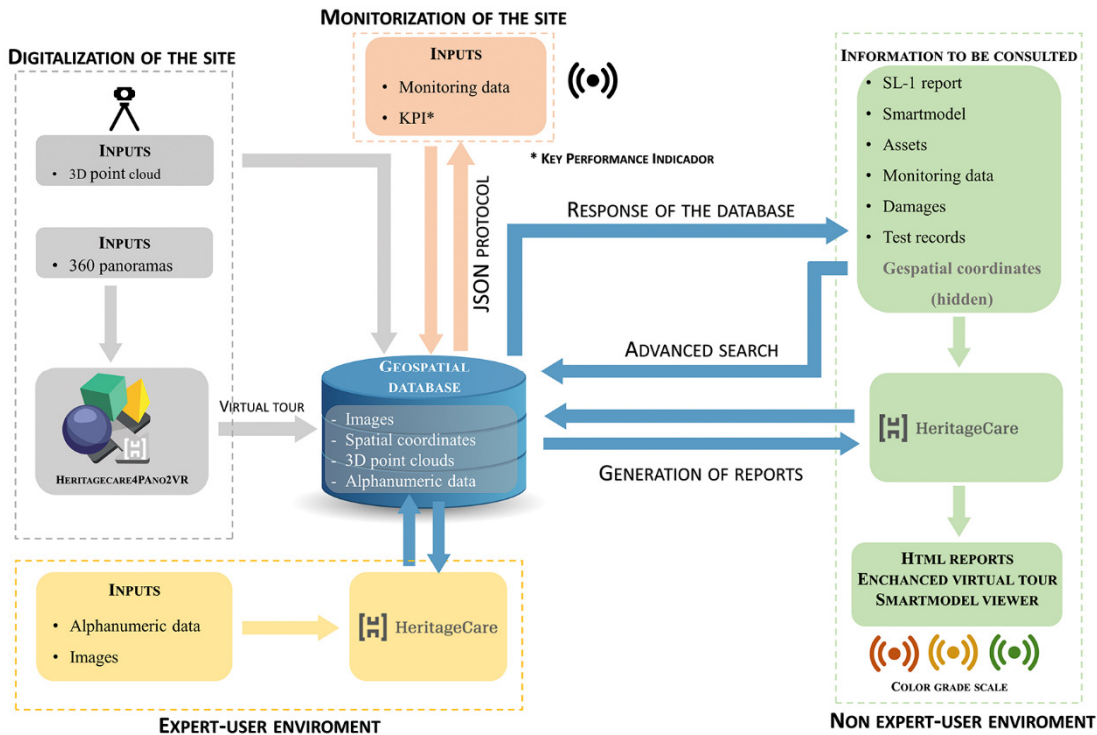
134  
 135 Figure 2: Flowchart of the PlusCare system and its main engines. The workflows carried out by the inspector are  
 136 presented in grey and yellow.

124 The efficient implementation of the PlusCare protocol required the development of a tool able not  
125 only to integrate different data sources (including the IoT), but also to provide an intuitive  
126 environment from which buildings' owners and managers (non-expert users) could access all the  
127 significant information for the effective preventive conservation of their heritage. To make this  
128 possible, a novel Web-GIS system was created: PlusCare. Such a tool combines the latest  
129 advances in geodatabase models, interoperability protocols and digitalization strategies, to enable  
130 the proactive conservation of historical constructions. Figure 2 shows the flowchart of the system  
131 as well as its main engines. As schematized, the PlusCare system converges into a dual web

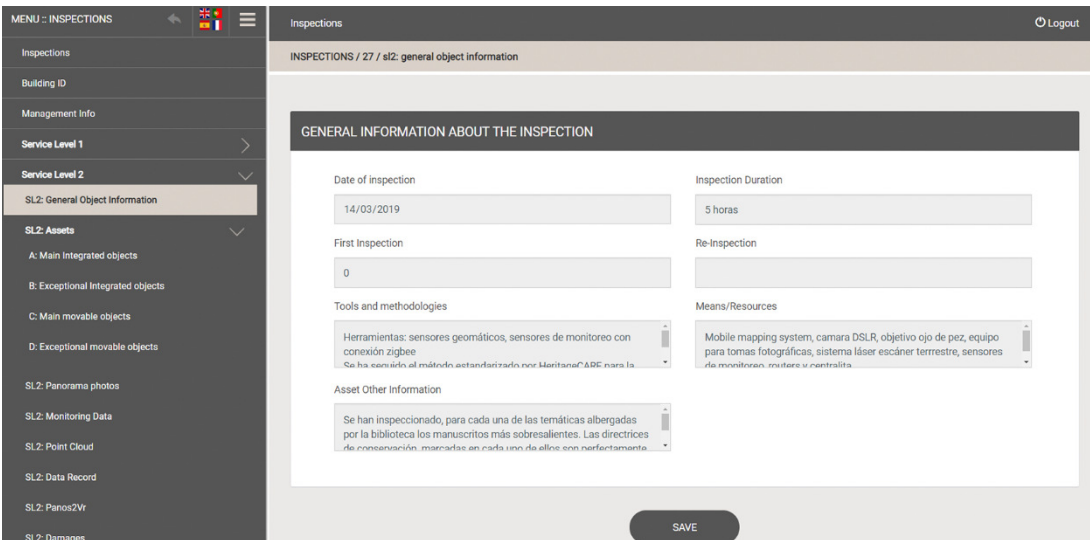
The image shows a screenshot of a web application interface. On the left is a dark sidebar menu with the title 'MENU : INSPECTIONS'. It contains several expandable sections: 'Inspections', 'Building ID', 'Management Info', 'Service Level 1', 'Service Level 2', 'SL2: General Object Information' (which is currently selected and highlighted), 'SL2: Assets' (with sub-items A, B, C, D), 'SL2: Panorama photos', 'SL2: Monitoring Data', 'SL2: Point Cloud', 'SL2: Data Record', 'SL2: Panor3D', and 'SL2: Damages'. The main content area has a header 'Inspections' and a breadcrumb 'INSPECTIONS / 27 / sl2: general object information'. Below this is a form titled 'GENERAL INFORMATION ABOUT THE INSPECTION'. The form contains several input fields: 'Date of Inspection' (14/03/2019), 'Inspection Duration' (5 horas), 'First Inspection' (0), and 'Re-Inspection'. There are also two dropdown menus: 'Tools and methodologies' and 'Means/Resources'. At the bottom of the form is an 'Asset Other Information' field with a text area containing Spanish text. A 'SAVE' button is located at the bottom right of the form area.

148 information is demanded (Figure 3): i) assets; ii) panorama photos; iii) monitoring data; iv) point

149 clouds; v) data records; vi) damages. The right body of the environment shows all the fields that  
150 the expert user needs to fill in depending on the tab selected on the left sidebar.

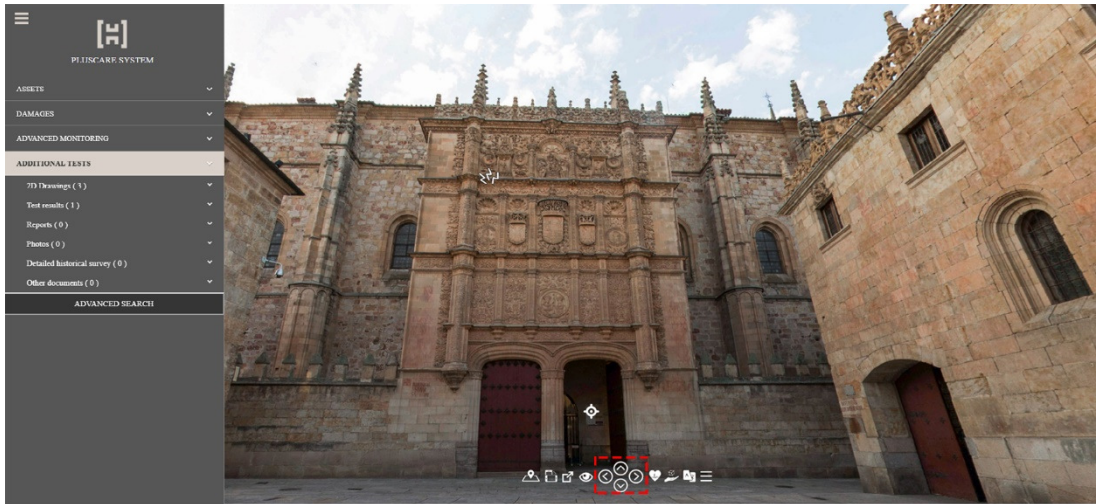
Figure 9: Interface of the non-expert user environment with the tab *Additional Tests* unfolded in the left sidebar. The buttons placed inside the red rectangle correspond to the group of buttons *e*.

293 graphical user interface is complemented by a bottom navigation bar that allows to consult the  
294 3D point cloud of the site and the SL1 condition report (Figure 10a). As shown in Figure 9, this  
295 navigation bar includes nine different groups of buttons (from left to right): i) button *a* to  
296 show/hide the map; ii) button *b* to enable/disable the gyroscope app; iii) button *c* to visualize the  
297 environment in full-screen mode; iv) button *d* to see or hide the hotspots of the virtual tour; v)  
298 group of buttons *e* to move the panoramas up, down, left and right; vi) button *f* to load the SL1  
299 condition report; vii) button *g* to connect the virtual tour with the 3D point cloud viewer; viii)  
300 button *h* to define the language; and ix) button *i* to hide/unhide the sidebar menu. It is worth  
301 mentioning that the platform includes a specific library for reading the data coming from the

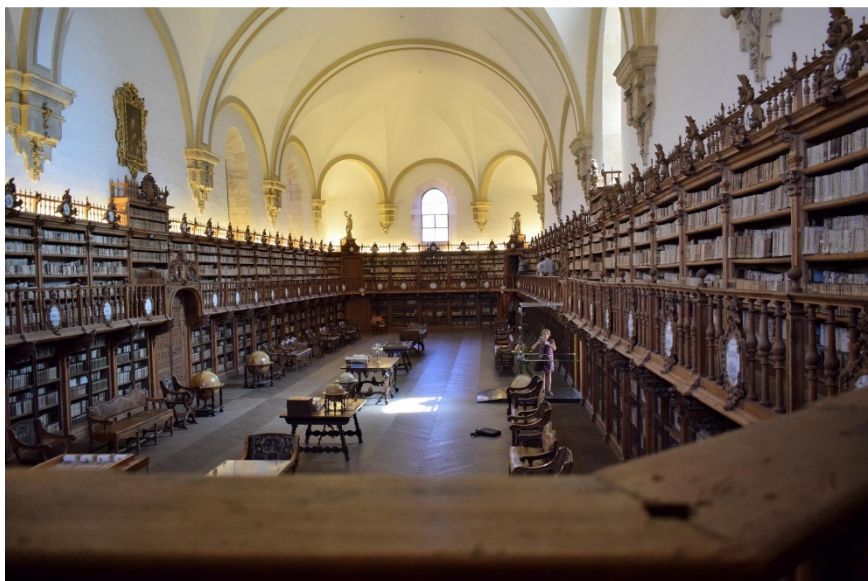
Figure 14: Interior view of the General Historical Library.

371 façade. It features a squared plan with a length of 41 m and a width of about 11.5 m (Figure 13).  
372 Its current appearance dates back to 1749 as a result of the restoration works carried out by Manuel  
373 de Lara Churriguera (Figure 14). The inner space of the library is covered with a vaulted system

386 shelves carved in Baroque style. Additionally, the Historical Library holds ten terrestrial, celestial  
387 and armillary spheres made of wood, paper and metal, as well as several vitrines, tables and chairs  
388 in leather and wood [27] (Figure 14).

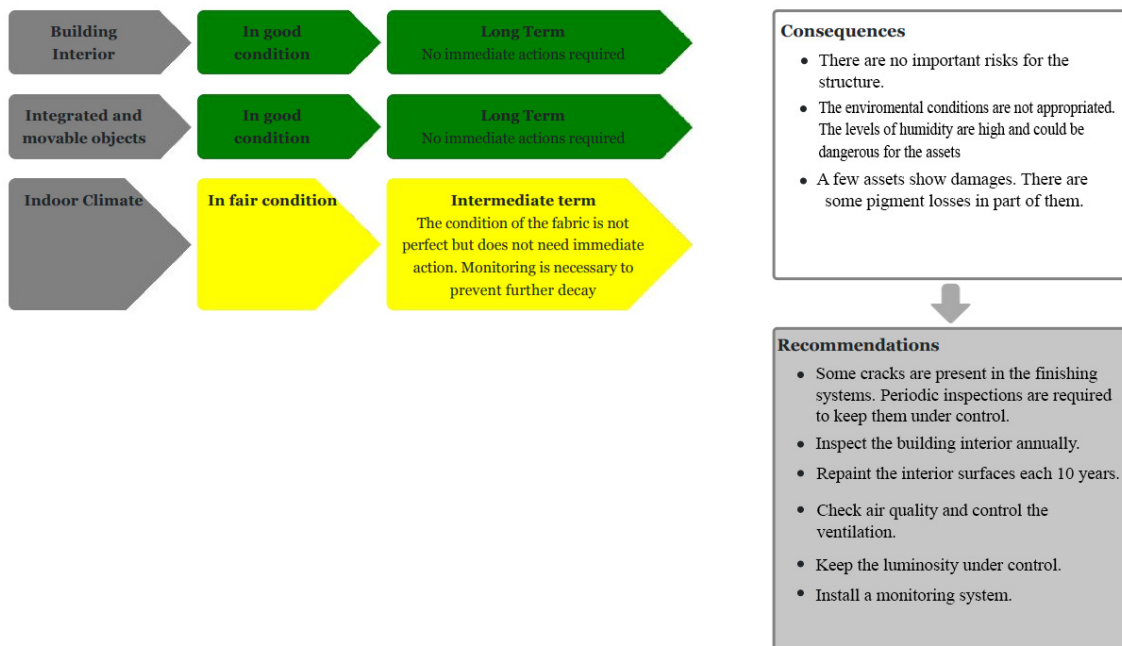
402 Figure 15: Chart of the building interior highlighting the priority of intervention together with the possible  
403 consequences if no preventive measure is adopted.

394 The Library was first inspected by an equipped team of HeritageCare professionals who applied  
395 the StandardCare protocol foreseen for SL1. This protocol allows a rapid condition screening of  
396 the conservation status and uses a 4-colour grading scale to associate a degree of severity to each  
397 observed damage [4]. This *modus operandi* permits to rank the overall building condition based  
398 on the average grade scored by each inspected building item, thus assisting in the definition of  
399 priorities of intervention or, alternatively, additional inspection and diagnosis works (Figure 10a  
400 and Figure 15) [4].

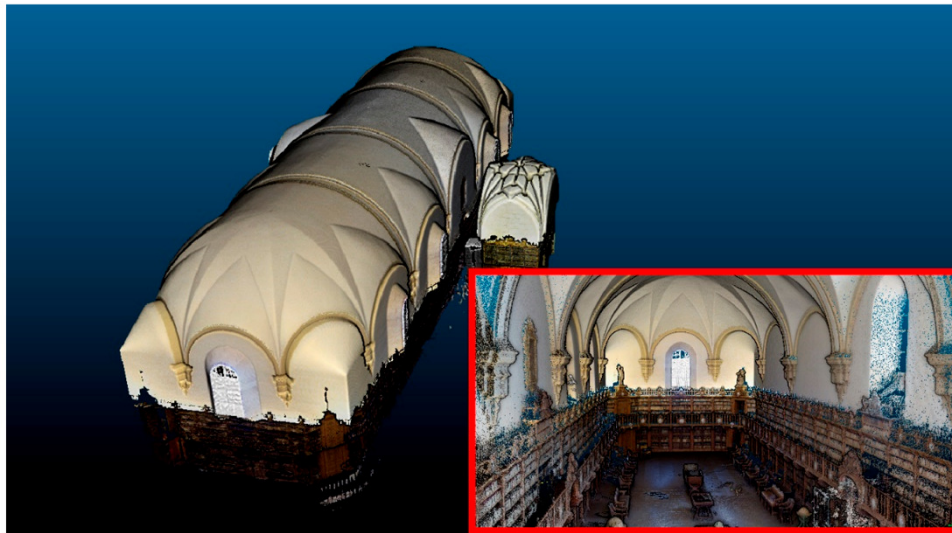
428 Figure 16: Result of the digitalization stage: a) plan view with the location of the stations; b) optimized point cloud  
429 within the open-source software CloudCompare®. Note: blue dots represent scan stations with panoramic images and  
430 red dots indicate stations with panoramic images only.

413 To obtain high-resolution information about the geometry and onsite conditions of the Library, a  
414 digitalization campaign was carried out to collect panoramic images and capture 3D point clouds.  
415 The former were acquired by means of the Canon 700D® DLRS camera. This DLRS camera has  
416 a 22.3 x 14.9 mm CMOS sensor with 18 MPx resolution (5196 x 3463 px), a pixel size of 4.29  
417 µm and a crop factor of 1.61. This device was equipped with a Sigma 8 mm circular fisheye lens  
418 with a maximum aperture of f/3.5 and a focus engine. Each station required a total of seven shots  
419 with 60% of overlap between them. As for the present campaign, 13 equirectangular panoramas  
420 were taken (Figure 16): i) 1 to digitalize the main façade; ii) 4 to capture the outdoor space of the  
421 inner cloister; iii) 2 for representing the hall of the inner cloister next to the Library; iv) 6 for the

422 digitalization of the Library. The different shots were stitched with the open-source software  
423 Hugin®. It is noted that each panorama was captured in the same position as the laser scanner  
424 station aiming at colouring the TLS point clouds. This was possible thanks to the use of the  
425 platform designed by Del Pozo et al. [28] (Figure 16b). Afterwards, the “basic” virtual tour was  
426 created in Pano2VR® with the assistance of the plugin *HeritageCare4Pano2VR*.

431 The 3D digitalization of the Historical Library was performed by means of the light-weight TLS  
432 Faro Focus 120®. This laser scanner is based on the phase shift physical principle with a  
433 measurement range from 0.6 to 120 m, a capture rate from 122,000 to 976,00 points per second  
434 and a nominal accuracy of 2 mm at 25 m in normal conditions of illumination and reflectivity. As  
435 a result, 6 scan stations were needed to record the Historical Library. All these scan stations were  
436 registered in a common coordinate system using to this end the Iterative Closest Points algorithm  
437 [29] by applying the strategy defined by Sánchez Aparicio et al. [30]. The final error after the  
438 alignment of the different point clouds was  $3 \pm 2$  mm. The huge amount of captured data, with a

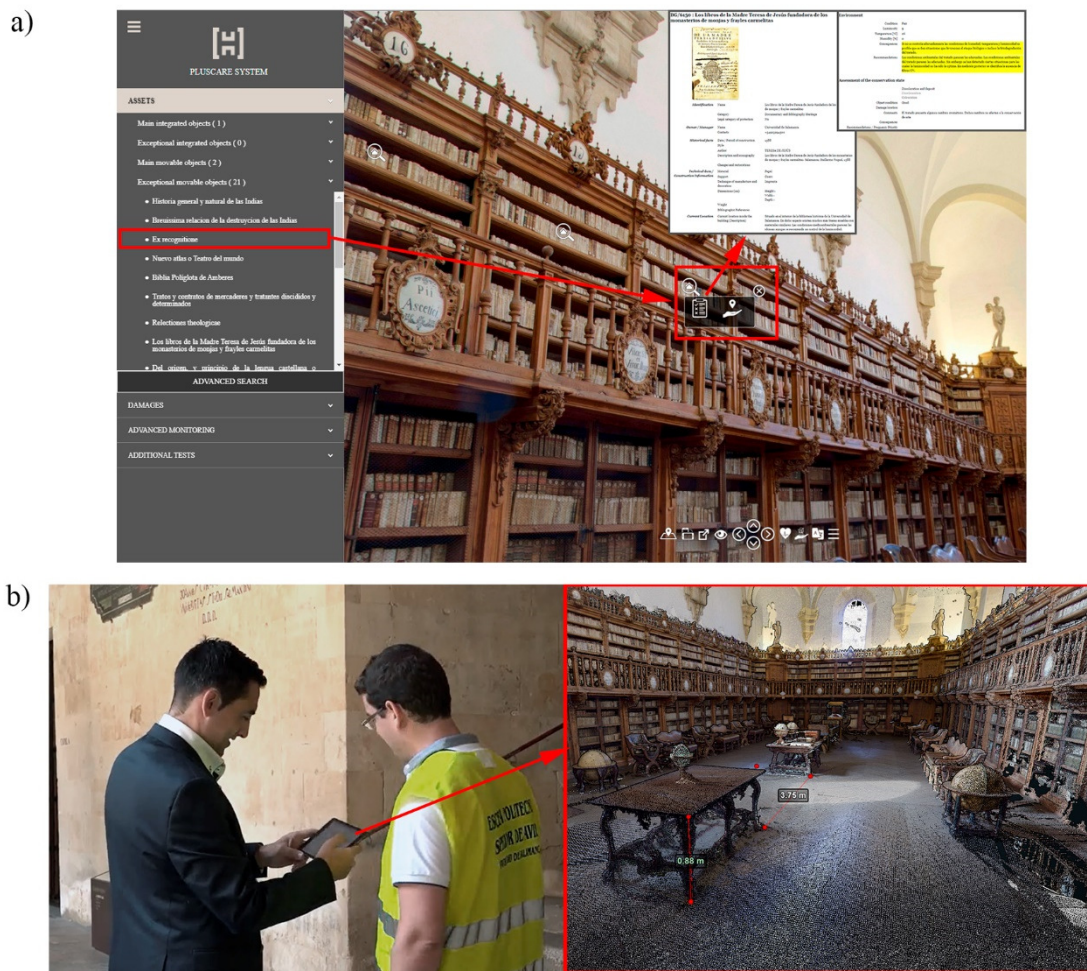
575 Figure 19: Non-expert user environment: a) consultation of SL2 condition report (yellow paragraphs indicate a fair  
576 damage condition, while green means that the damage severity is low); b) consultation of measurements within the  
577 3D point cloud.

570 The 3D icon of the bottom navigation bar of the PlusCare interface gives the user the possibility  
571 to access and browse through the tridimensional high-resolution survey of the heritage site. The  
572 visualization is boosted by the Octree system, allowing to check it on mobile devices (Figure  
573 19b).

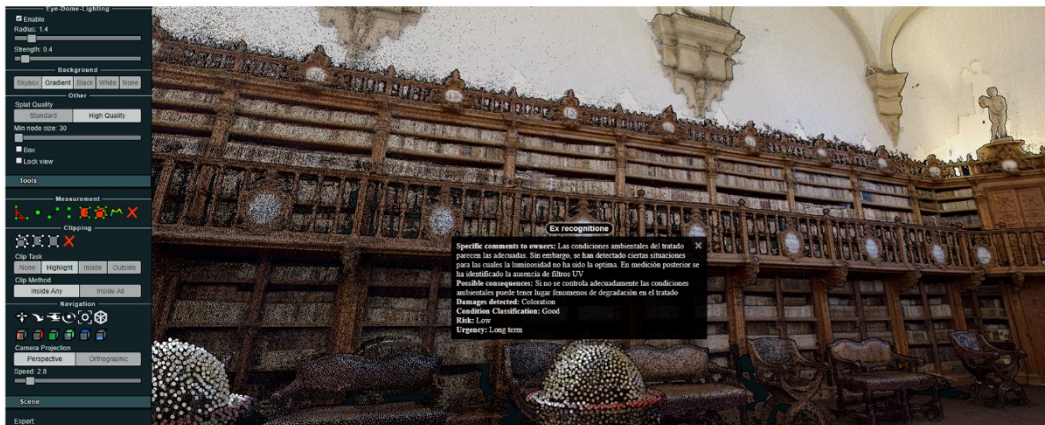
Figure 20: Non-expert user environment: a) consulting information about the asset condition; b) pop-up box related to the asset hotspot (yellow paragraphs indicate that the environmental conditions are not appropriate for the selected asset); c) 3D model

579 The rest of the information stored by the inspectors into the PlusCare database, such as the assets  
580 condition, the damages or any additional record (see Section 2.2.1.5), is plotted in the non-expert  
581 user environment by means of pre-defined hotspots inserted within the pertinent 360° photos that  
582 compose the virtual tours. The full list of hotspots among which the user can navigate is available  
583 in the left sidebar, grouped by category (Figure 20a and b). The optimal connection between the  
584 database and the virtual tour ensures a quick browsing among the different objects directly from  
585 the sidebar menu of the interface, and regardless of the filter applied for the advanced search. In  
586 this way, if the user does look for a specific asset and selects its name, the platform automatically  
587 places the user's point of view in the area where the selected asset is located (Figure 20b).

588 Furthermore, if the user clicks on that object hotspot, a window pops up allowing to consult both  
589 the asset inspection report (Figure 20b) and its location within the 3D model (Figure 20c). The  
590 transfer of information associated with damage and test record hotspots is plotted in the same  
591 way.
