1 **HERITAGE PRESERVATION BY COMBINING RADIOMETRIC AND GEOMETRIC**
2 **ANALYSIS OF TLS DATA: THE SAN FRANCISCO MASTER GATE IN ALMEIDA**
3 **(PORTUGAL)**

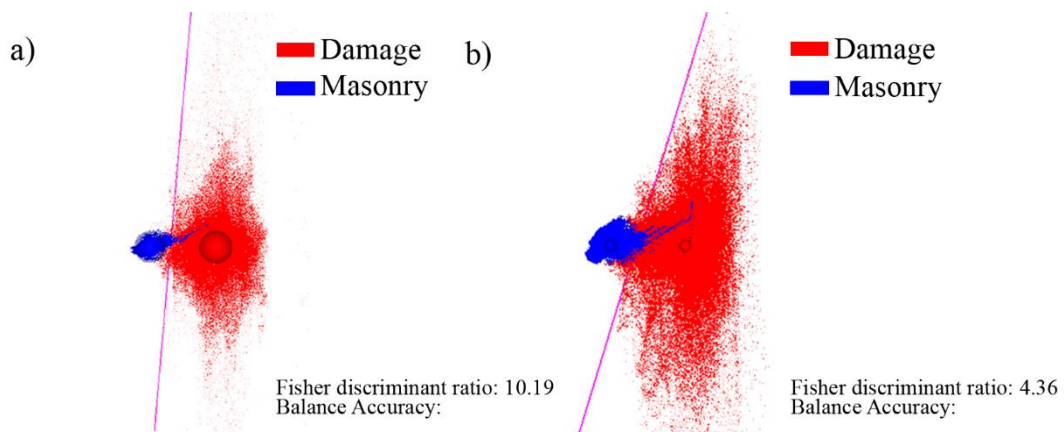
274 **Figure 6:** Results during the CANUPO training: (a) Classifier A; (b) Classifier D. In red is the damage class, in blue
275 masonry and in magenta the hyperplane of maximal separability.

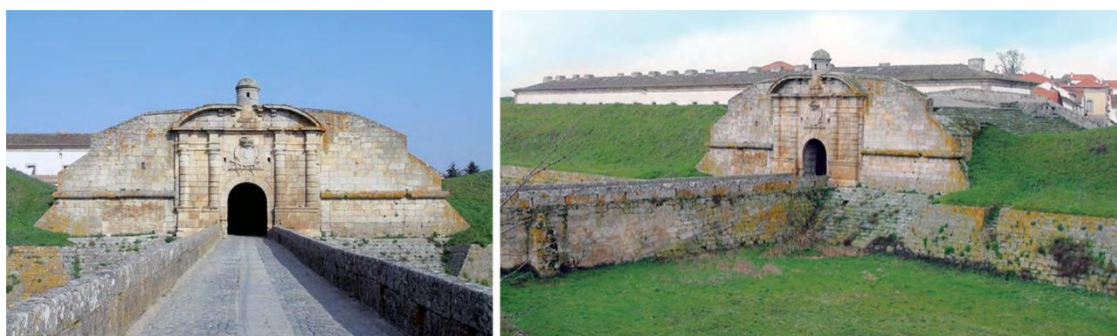
327 In 1986, work continued in the San Francisco Master Gate, where the right side urgently needed
328 consolidation and cleaning of the masonry. The mortar used during this restoration was a
329 hydrophobic mix with cement with an estimated proportion of 1:2/3:6 (cement:lime:sand) [35].
330 Figure 10 shows its current aspect.

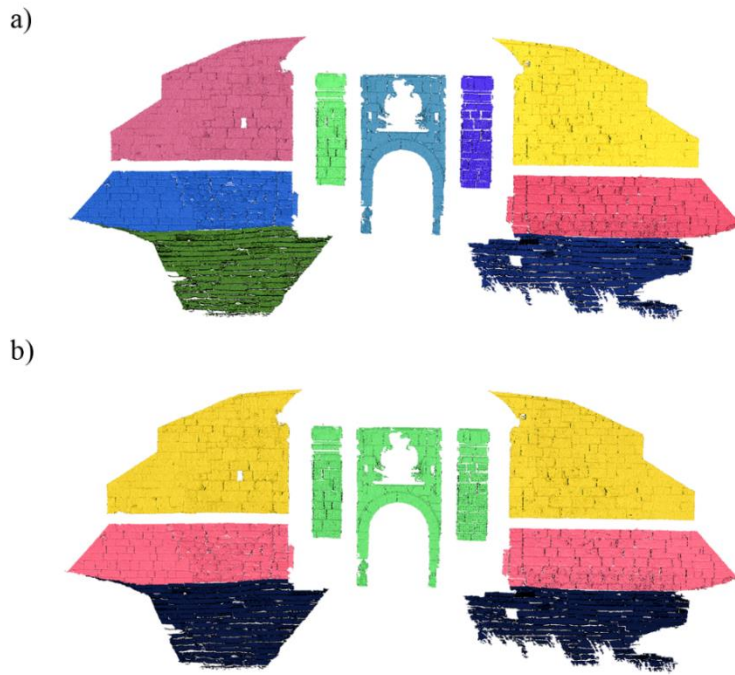
436
437 **Figure 16:** Segmentation carried out on façade B: (a) clusters obtained through the RANSCAC shape detector; (b)
438 planes clustered according with their similarity.

432 Regarding façade B, several planes were obtained by means of the RANSAC shape detection,
433 requiring an additional clusterization process. This segmentation was based on the similarity, in
434 terms of plane normal and centroid position, between clusters (Fig. 16, 17 and 18).

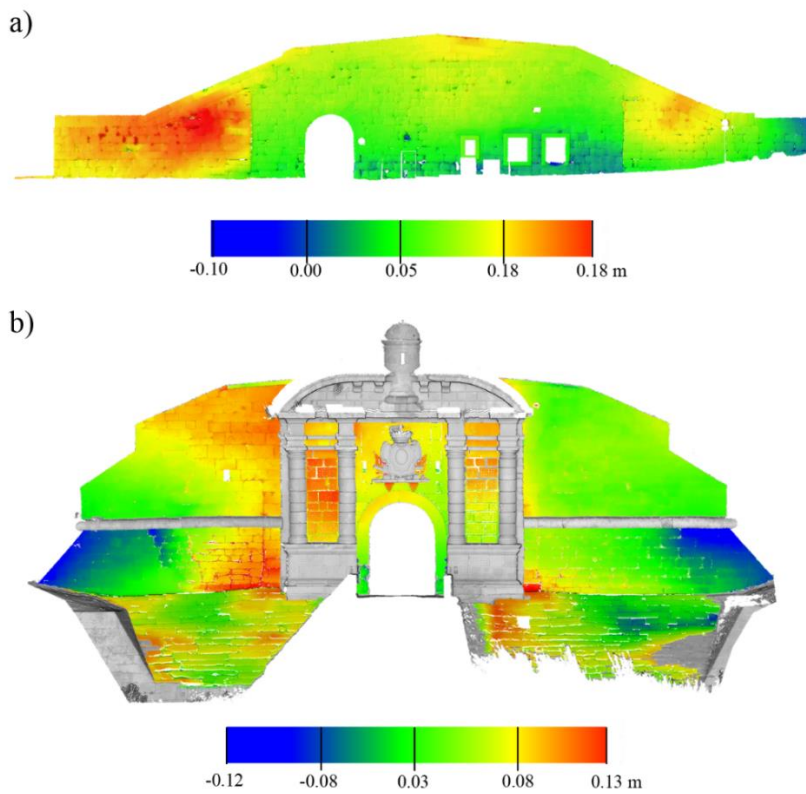
439
440 **Figure 17:** Results obtained during the deformation analysis: (a) façade A, with a unique vertical plane; and (b)
441 façade B with vertical and non-vertical planes.

521 With respect to the deformations, façade A shows out-of-plane deformations (with a maximum
522 displacement of 0.18 m) on the lateral retaining walls (Fig. 17b). Those two walls are completely
523 split for the gate building by a construction joint (Fig. 23). On the left side, the maximum
524 deformations are close to 0.18 m but with a random distribution without showing the tilt of the
525 wall. This deformation could be due to a construction defect. On the other side, the maximum
526 deformation appears on the top of the wall, indicating a local tilt on the wall or a bubble in the
527 wall. The maximum value is also close to 0.18 m (Fig. 17b). Concerning Façade B (Fig. 17a), it
528 is possible to observe out-of-plane deformations on the vertical plane of the façade. No tilting
529 configuration is visible, since the deviations are almost constant with a maximum of 0.13 m. The
530 deviations are most probably due to construction defects or derived from the intensive
