Adapted ageing tests for the evaluation of alabaster used in the restoration of Bishop's Palace of Tarazona

ABSTRACT: The advanced condition of deterioration of the column's bases of the courtyard of the Bishop's Palace of Tarazona (Spain) built in the middle of 16th century required its restoration with *Aragonese* alabaster. Thus, adapted ageing tests were developed to simulate the environmental conditions in which the stones were and will be exposed. These tests were thermal fatigue by temperature variations, acid rain and water stagnation by immersion tests and a combination of both agents of decay. The results indicated that alabaster did not experienced deformation after thermal fatigue but a progressive dehydration to bassanite. This process entailed an increase of porosity and consequently a loss of structural properties. The dissolution was measured as a lineal weight and volume loss while porosity and capillary uptake remained stable. The conclusions of this study establish the importance of restoration protocols to maintain the alabaster integrity when used and exposed to rainwater and insolation.

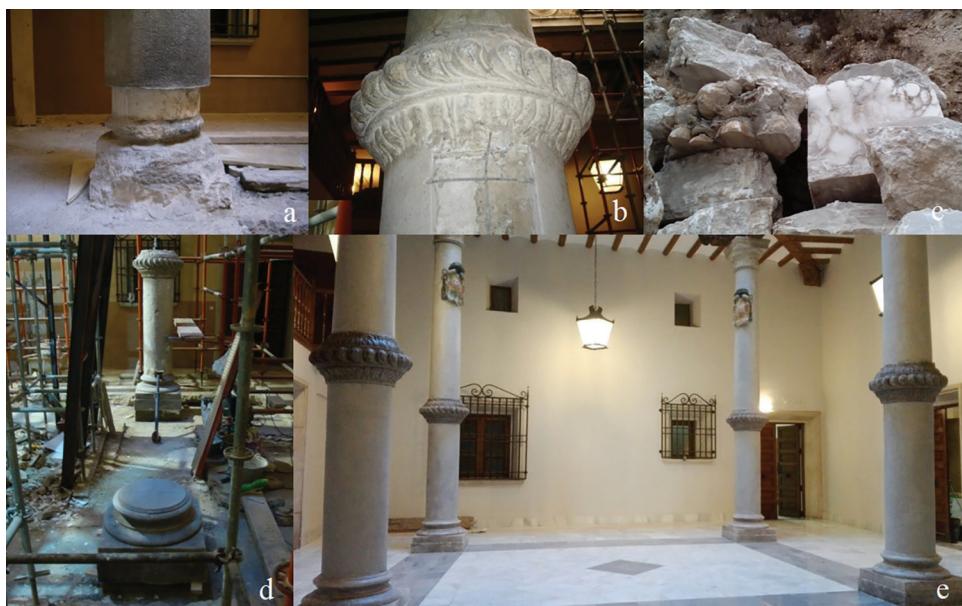
FIGURE 1. a. Removal of mortar on base. b. Removal of reinforcement mortar that covered lower part of carved ring and shaft. c. Alabaster quarry. d. New bases. e. Restored alabastrine gypsum columns.

1.1. Restoration of court's columns

In the restoration works carried out between 2016 and 2017 (9), the columns were dismantled to make a new concrete foundation. Previously the ground was consolidated with anchors and some floors of the palace were tied with stainless steel bars. Therefore, the reinforcing mortar of the bases was removed and new bases of alabaster of chromatic tonality similar to the previous ones were carved. The “*bardillo*” variety of Fuentes de Jiloca was chosen for this study since this is the alabaster that is currently being exploited (Figure 1.c). Then, the columns were reassembled (Figure 1.d). Knowing the vulnerability of the material to rainwater, the court has been covered with a glass skylight. In addition, a superficial cleaning was carried out, as well as the restitution of stucco of the bottom shaft and the polychrome of heraldic shields (Figure 1.e).

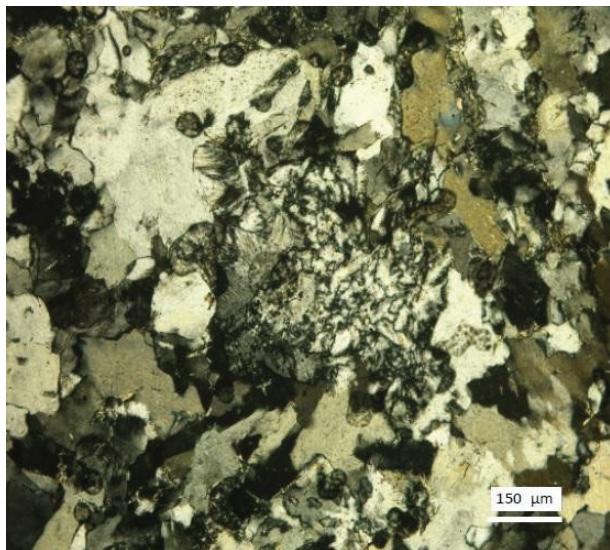
FIGURE 2. Alabastrine texture in the centre of upper shaft (12).

The petrographic characterization of the column samples (base and upper shaft) revealed that visually both samples showed a granular texture, with gypsum crystals of variable size (0.1 mm to few mm) as white and translucent crystals, both encompassed by a clayey brownish matrix. By microscopic assessment, three crystal distributions were observed in the base sample. The first type were gypsum aggregates of 1–2.5 mm with a crystal sizes of 20 to 100 µm with the typical alabastrine texture; the second one were allotriomorphic crystals with sizes comprised between 50 µm and 0.5 mm; the last type were subidiomorphic crystals of higher size, from 0.5 to 1.5 mm with anhydrite inclusions. This base sample showed 34% of alabastrine texture, 56% of granular subidiomorphic texture, 8% of marly matrix (clay and carbonate) and 2% or relict anhydrite. In the upper shaft, 75% of the sample revealed a granular subidiomorphic texture with crystals of very variable size, from 100 to 300 µm generally, but up to 2500 µm in rare cases. The alabastrine original texture was only represented in a 13%, with gypsum crystals under 50 µm. In this sample, the marly matrix proportion with clays and carbonate was of 11% while relict anhydrite was only 1% (Figure 2).

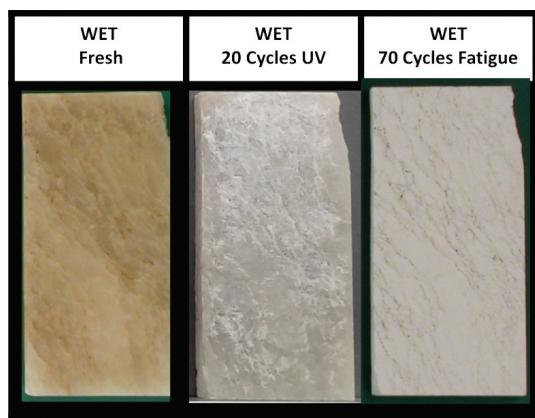
FIGURE 3. Surface appearance after thermal fatigue test.

the second test, carried out afterwards on the same samples, the slabs become completely white with almost no differences between the dry and the wet conditions. The small differences were located on the fissures, with light brown color which turned in darker colors after wetting. The aspect of the samples is shown in Figure 3.

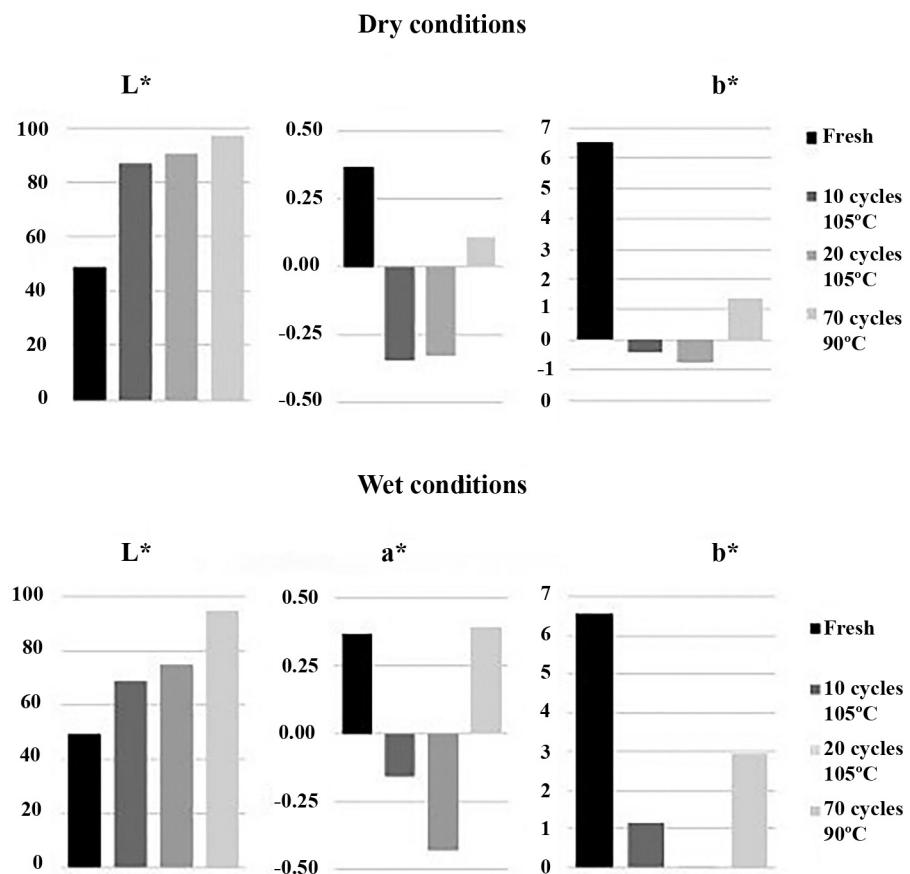
FIGURE 4. Color evolution after thermal tests in dry and wet measurement conditions.

The color evolution from the fresh stone slightly dampened to the dry samples with the white powdery layer was very evident during the first cycles and only small variations were measured from then. Initial values of lightness (L^*) were medium/dark due to the sample's translucency and changed to values around 90 with the bassanite transformation. The decrease in b^* from yellow colors to white ones was also remarkable (Figure 4).

The color evolution between wet samples showed the same trend but with bigger differences from 20cycles to the end of the following 70 cycles. The tone of the final samples (a^* and b^* parameters) was more vivid in the wet samples due to brownish-ing of the fissures filling in contact with water.

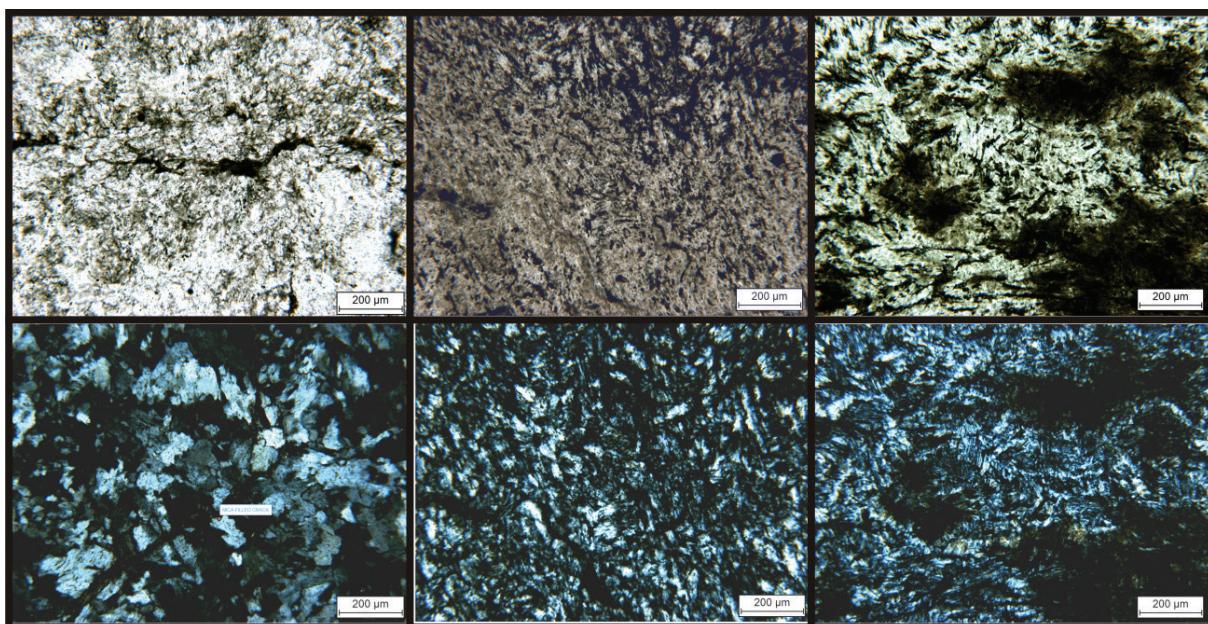
FIGURE 5. Microscopical observation with non-polarized (up) and polarized (bottom) light. Sound alabaster with alabastrine texture (left); cubes after insolation test and the textural transformation to bassanite (center); slabs after insolation test showing the progression of the textural transformation (right).

was not complete. Microscopical observations of the sound stone before testing and the slabs and the cubes after thermal tests, revealed notable differences between them (Figure 5). The heated samples exhibited a change in the texture, with a decomposition in micrograins that corresponded to fibrous bassanite (center and right, also observed in (15)). With non-polarized light, the bassanite advance from the fissures is clear. Crystals are homogeneous in size, with dimensions between 150–200 µm. Anhydrite proportion increased from around 5% in the cubes and 10% on the slabs, close to DRX results.

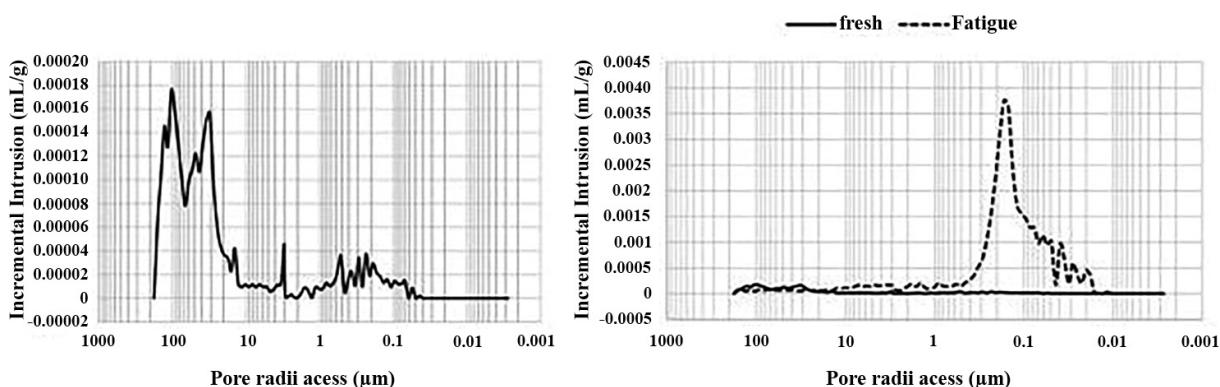
FIGURE 6. Pore radii access distribution obtained by Hg porosimetry of the fresh samples (left) and compared after thermal fatigue (right, vertical axis x20).

temperature changes without any difference through the sample. Capillary water uptake was measured after 20 and the following 70 cycles of thermal variations. The initial capillary coefficient was null and so was after 20 cycles. The fissure network had not suffered any variation that would allow the water entering through the stone. At the end of all the tests, the average capillary coefficient increased to $146 \pm 5 \text{ g/m}^2 \text{ s}^{1/2}$. The porosity calculated by the hydrostatic measure method (EN 1936) revealed a porosity at the end of the test of 24–28%, very different from the <1% of the fresh samples. Mercury porosimetry revealed an increase of porosity up to 8% with a unimodal distribution and a peak around 0.15 µm (Figure 6).

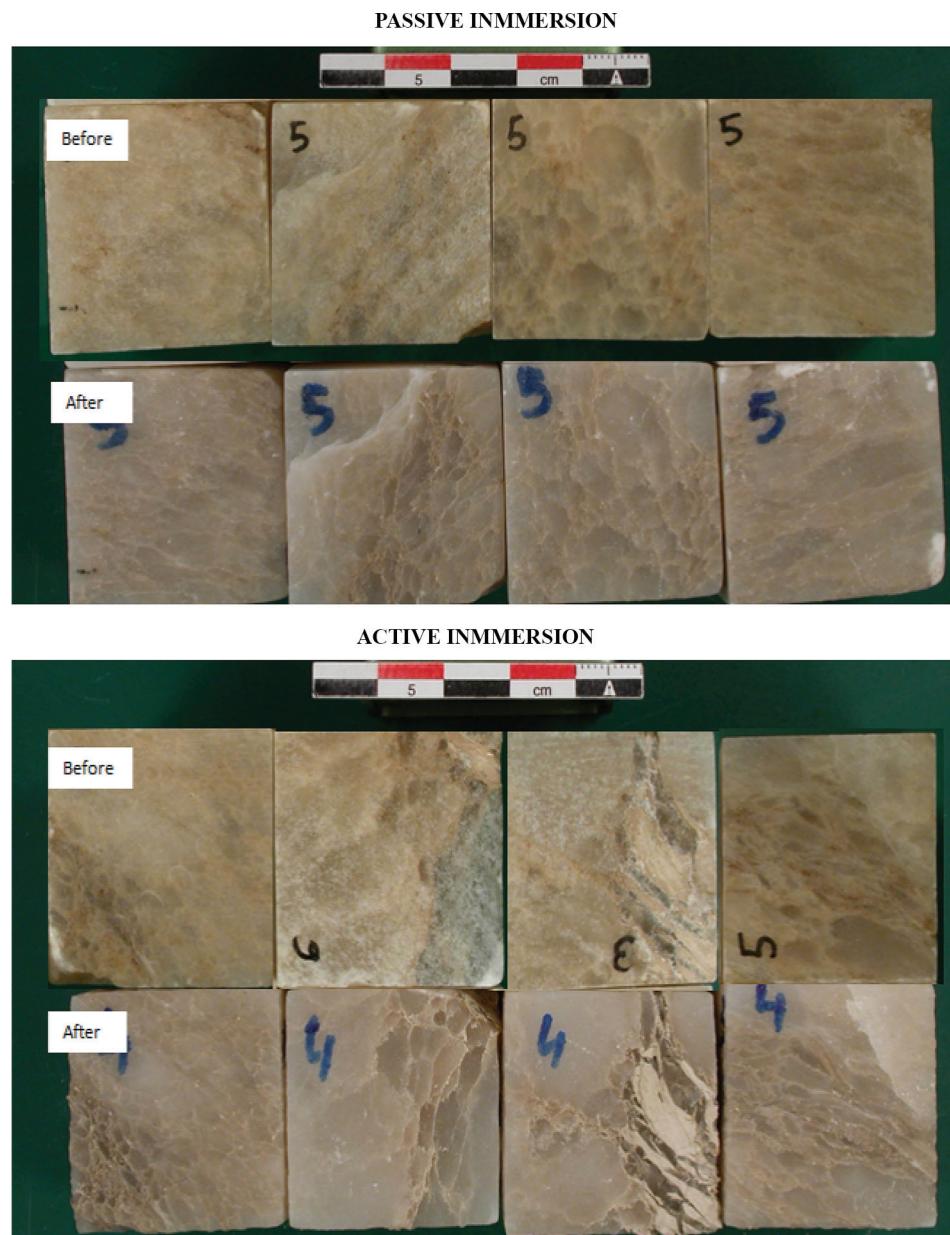
FIGURE 7. Comparison of surface condition after passive (up) and active (down) immersion tests.

The visual differences denoted a great change between samples and between tests (passive and active immersion). For all the samples, the surface increased its roughness. For both tests, the samples with a white homogeneous texture dissolved uniformly while the samples showing fissures experimented a differential dissolution. The clays that filled the fissures dissolved or fell mechanically slower than the gypsum and that created, a relief on the surface.

After the passive immersion test, the cubes showed a shape of slightly truncated tetrahedra,

keeping their dimension unaltered at the bottom and decreasing linearly through the top. That is due to the greater dissolution of the cube vertices completely exposed to the solution. During the active immersion the samples exhibited a homogeneous dissolution (Figure 7). The dimensions were measured in the fresh samples and after each week. The total volume loss for passive immersion was of 9% and for active immersion of 12.5%, which highlighted the great dissolution of the samples in contact with water and the important effect of the run-off water.

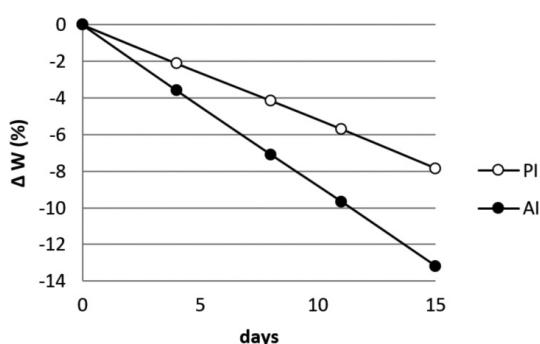
FIGURE 8. Weight loss in passive and active immersion tests.

immersion samples and more than 13% in active immersion, values comparable to the volume loss (Figure 8). The minimum and maximum loss weight in the passive immersion were around 1.65 g and 2.0 g during the first 4 cycles and between 6.3 g and 7.3 g at the end of the test. In the active immersion, the deviation between samples was noticeable with a loss during the first 4 cycles between 0.4 g and 5.8 g, and at the end of the 15 cycles between 9.5 g and 12.5 g.

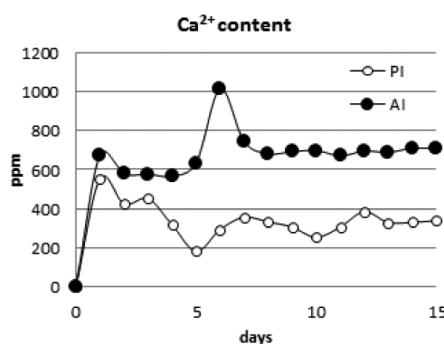
FIGURE 9. Evolution of the dissolved cations on the solution.

The dissolved cations of the solutions were analyzed every day. Ca^{2+} values corresponded to gypsum dissolution and Mg^{2+} to marly matrix components. The results showed that gypsum dissolves in a homogeneous way with similar values every day (Figure 9). Active immersion produced a greater dissolution due to the collision principle and the anomalous high peak was explained by the detachment of a piece of material, that increased that specific day the specific surface dissolving. The Mg^{2+} dissolved in water was extremely high the first day during active immersion and then stabilized. This high peak can be explained by the washing of all the detached clays on the surface due to the mechanical effect. In all the analyses carried out from the active-passive immersion, the Mg content was higher than in the passive one, indicating an action on the fracture fillings.

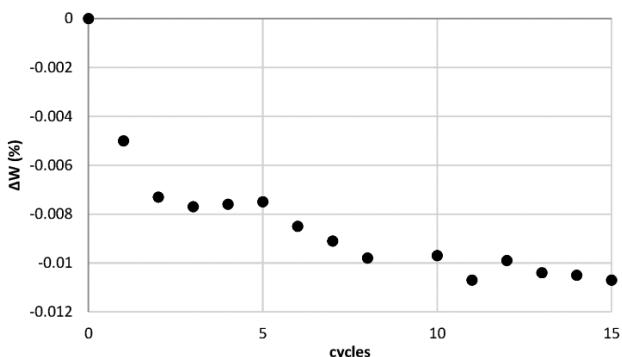
FIGURE 10. Weight loss during the combined test.

The weight loss measured every day revealed a sharp decrease during the first three days due possibly to the lack of pH equilibrium. After these days the loss was less accentuated but continuous with time (Figure 10). The measurement of the prism dimension highlighted the bottom dissolution with an area that decreased from 1623 mm² to 1597 mm², a height reduction from 69.96 mm to 69.21 mm and the univariate dimensions of the top surface.
