1 **An HBIM approach for the preventive conservation of historical constructions:**
2 **application to the Historical Library of Salamanca**

21
22 **Abstract**

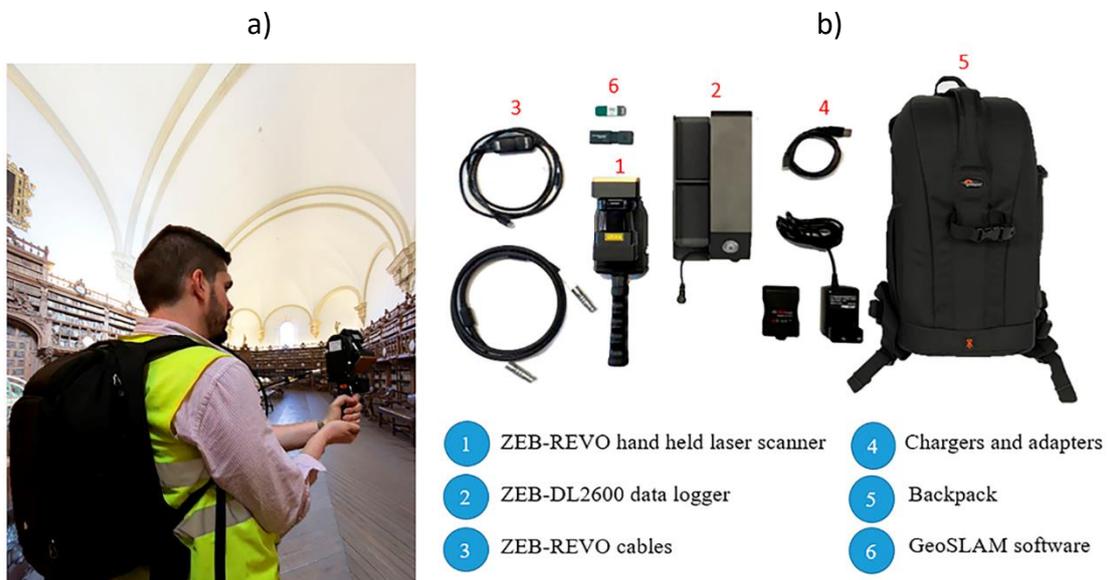
Figure 2. WMMS used: a) user working with the wearable laser scan (Zeb-Revo). b) Zeb-Revo equipment

423 The Zeb-Revo Wearable Mobile Mapping System from GeoSlam® [33]. was used for digitalizing
424 the library. The Zeb-Revo system consists of a rotatory head that comprises a 2D laser scan head
425 and an IMU. The head is connected to a processing unit, which is carried by the user in a backpack,
426 allowing the digitalization of large spaces while walking through them. The information captured
427 by the scan head and the IMU are finally integrated to create a 3D point cloud by means of a full-
428 SLAM algorithm [16], providing an accuracy that ranges from 1 to 3 cm.

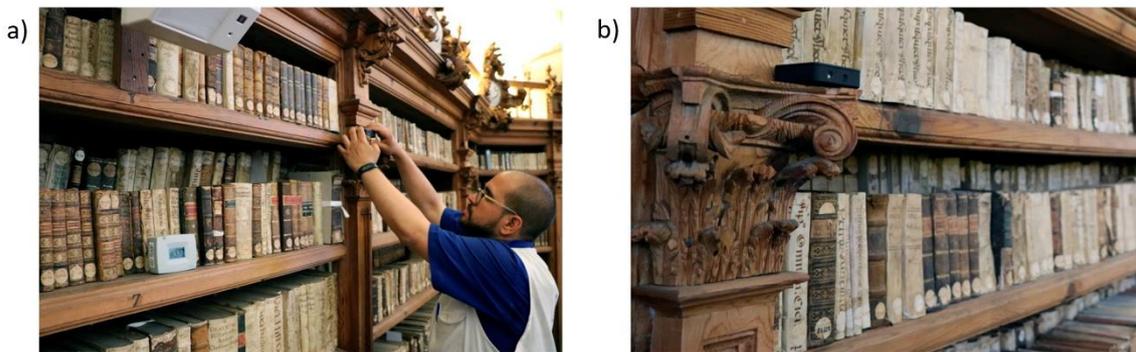
Figure 14. Nodes installation in the Library.

444 The final stage of the in-field works involved the installation of a monitoring network. A
445 total of 39 wireless nodes were placed along the Library (Figure 13 and Figure 14): i) 23
446 for monitoring humidity and temperature; ii) 1 for detecting the presence of people; iii) 8
447 for monitoring luminosity; iv) 2 for monitoring CO₂ in the environment; v) 2 for
448 monitoring solar radiation; vi) 2 for monitoring the presence of xylophagous; vii) and 1
449 methodological station. In addition to the two local nodes, there was a central node. This
450 node sent the information to the central computer (Figure 3). The data thrown by each
451 node can be consulted online, providing real time values (Figure 15). The monitoring
452 system is active since July 2019.

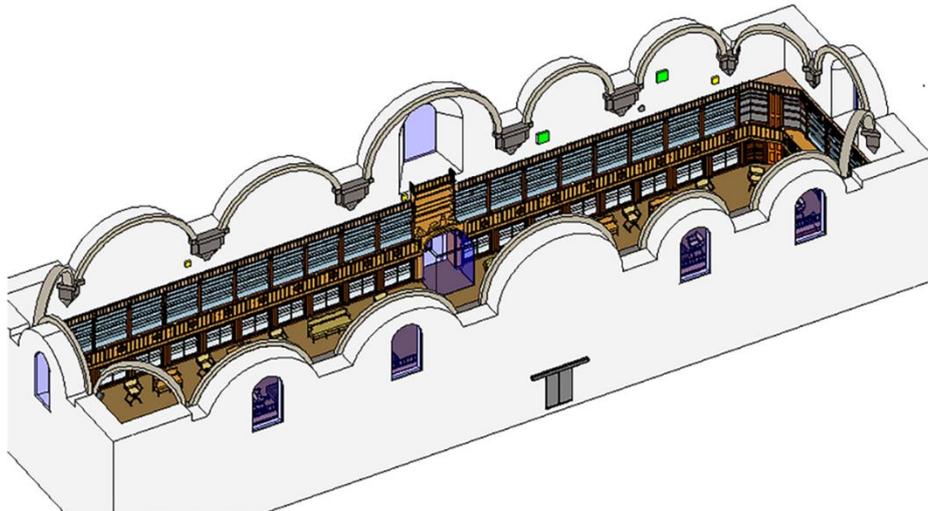
Figure 19. General view of the HBIM model on which is possible to observe the path-based families used to represent the damages and nodes of the monitoring network.

path-based families (Figure 19).

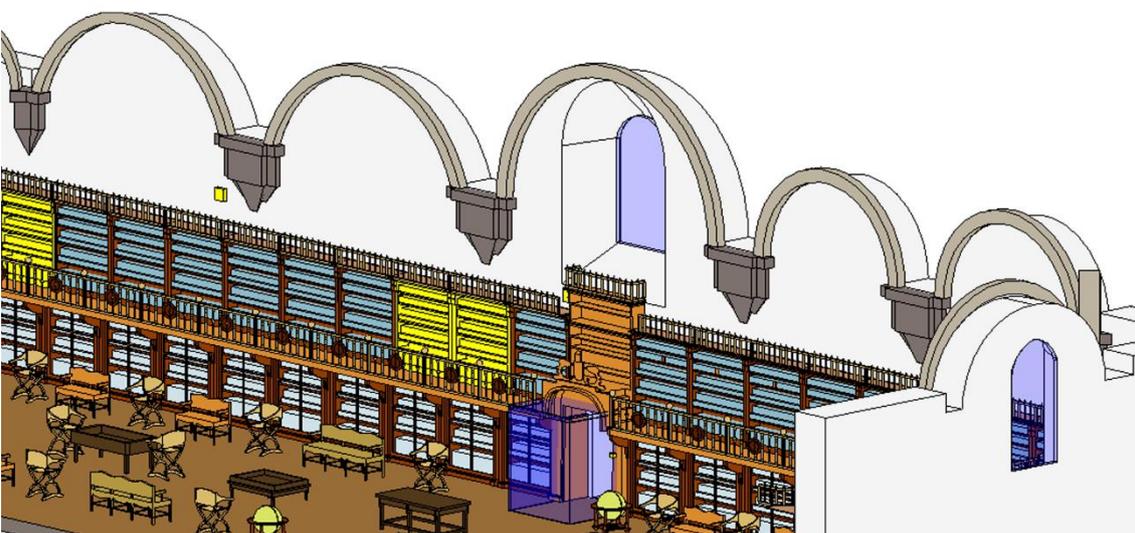
582 Figure 23: Graphical plots within the HBIM model: a) Urgency risk considering the absence of
583 ultraviolet (UV) filter and a proper ventilation system; b) urgency risk according with the conservation
584 status of the assets and; c) assets with presence of discolouration.

580 the plugin highlights the assets with a specific damage (Figure 23c).
