Proceedings  
PRO 130

Proceedings of the 5<sup>th</sup> Historic Mortars Conference

## **Similar appearance of mortar and brick masses in Algiers Casbah houses during the Ottoman period (16<sup>th</sup>- early 18<sup>th</sup> centuries)**

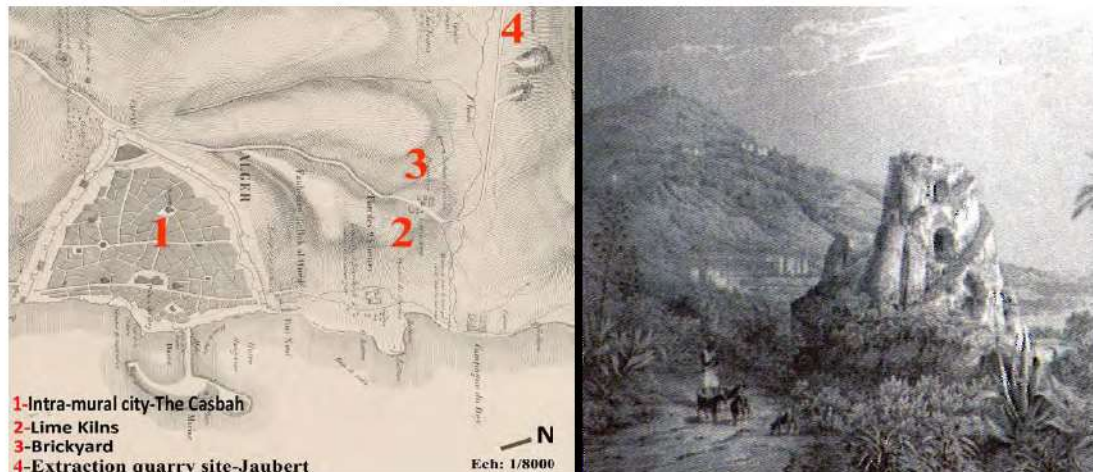
Figure 2. Left: Plan of Algiers and its surroundings in 1808 by BOUTIN. Right: Lime Kiln of the Faubourg Bab el Oued in 1838 by Adolphe OTTH (BNF-Gallica archives).

The materials used in the construction of the Casbah houses came from the nearby environment notably the quarries of Bâb el Oued Faubourg later known as Jaubert extraction site during the French period (Figure 2), except for the ceramic wall tiles that were imported from Tunis, Italy, Spain and Netherlands [6]. The thickness of the walls varies 40-90 cm; they were made of bricks or mixed masonries (*opus mixtum*), adding rubbles or blue stones, with the bricks arranged horizontally or to 45° (*opus spicatum*) and the mortars applied in broad layers like to the brick's thickness.

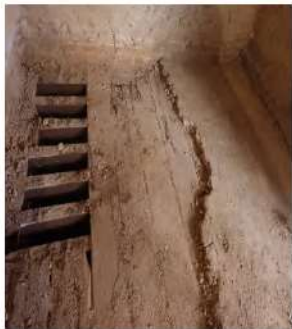
Table 1. Samples visual aspect and their location inside the construction.

House	Sample code	Material	Situation	Visual aspect
3 Imp Lavoisier	M1.3.E4a	Brick
